Physics of Failure Analysis for Roller Bearing Failures

Physics of Failure Analysis for Roller Bearing Failures: A tutorial explaining the Physics of Failure method applied to regularly failing roller bearings in a dewatering press. After three years of exhaustive efforts to solve the cause of the bearing failures it was decided to test Physics of Failure Analysis with the aim of finding a lasting answer.

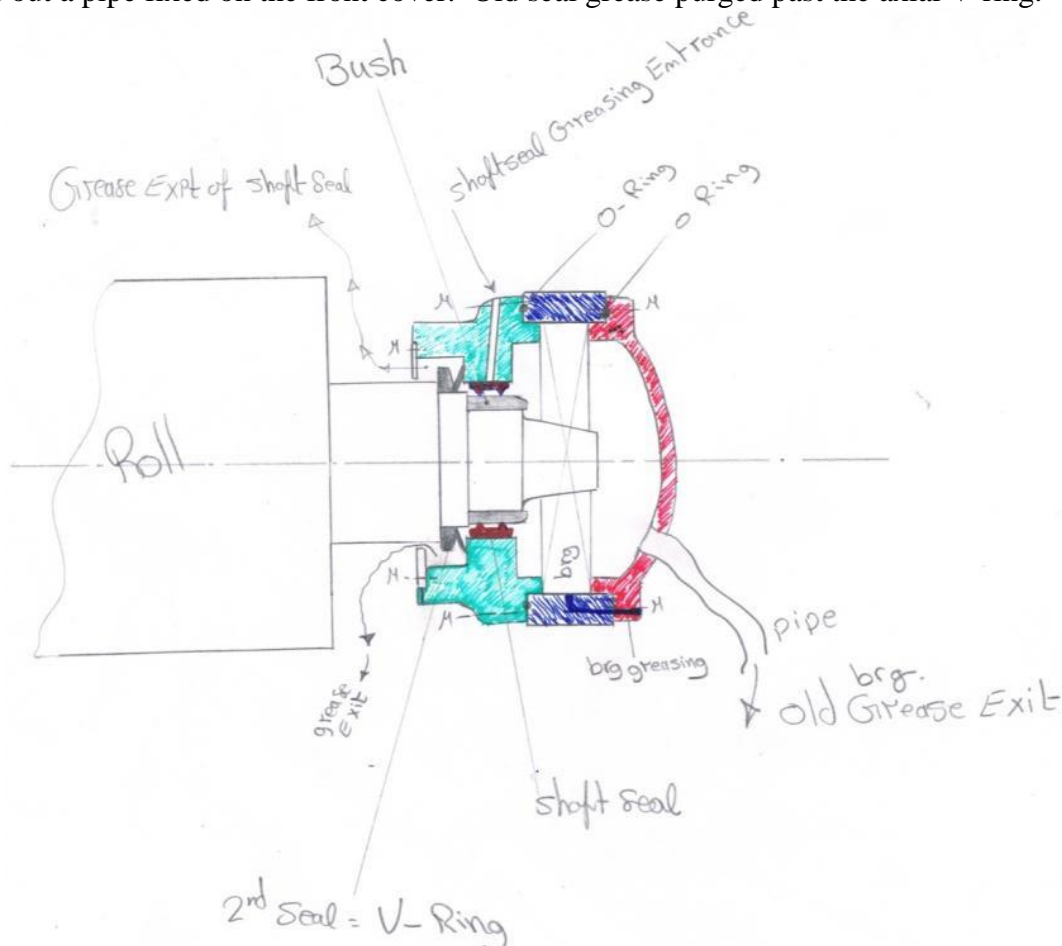
Figure 1 De-watering Press Roller Fixed End Bearing Arrangement

Figure 1 is the bearing arrangement at the roll ends. The bearing was a spherical roller tapered bore bearing 23236 CCK/W33 installed directly on the taper shaft. Old grease from the bearing purged out a pipe fixed on the front cover. Old seal grease purged past the axial V-ring.

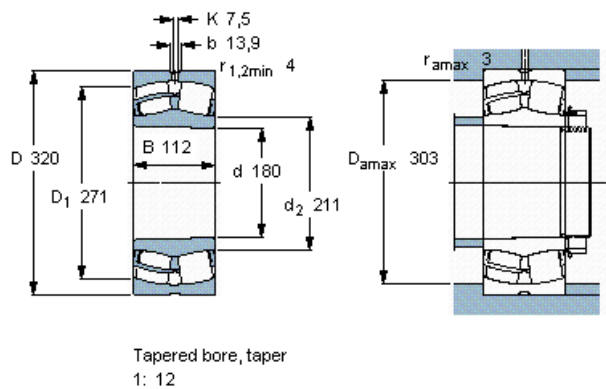
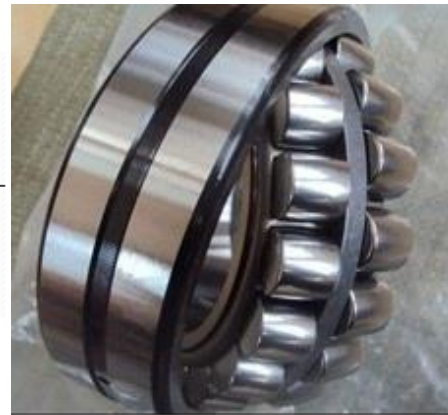
Figure 4 23236 CCK/W33 Bearing Details

The spherical roller bearing design details were as shown in Figure 4.

“The history of the failures shows that 80% of the damage is on one side of the outer ring, 20% of the bearings are damaged on the other side, which indicates an axial load (but the 4 press roll sets are driven by the wire, no direct driving motor.). The rolling elements always have minor damage—black spots and raceway contact damage, as shown in Figure 5.”

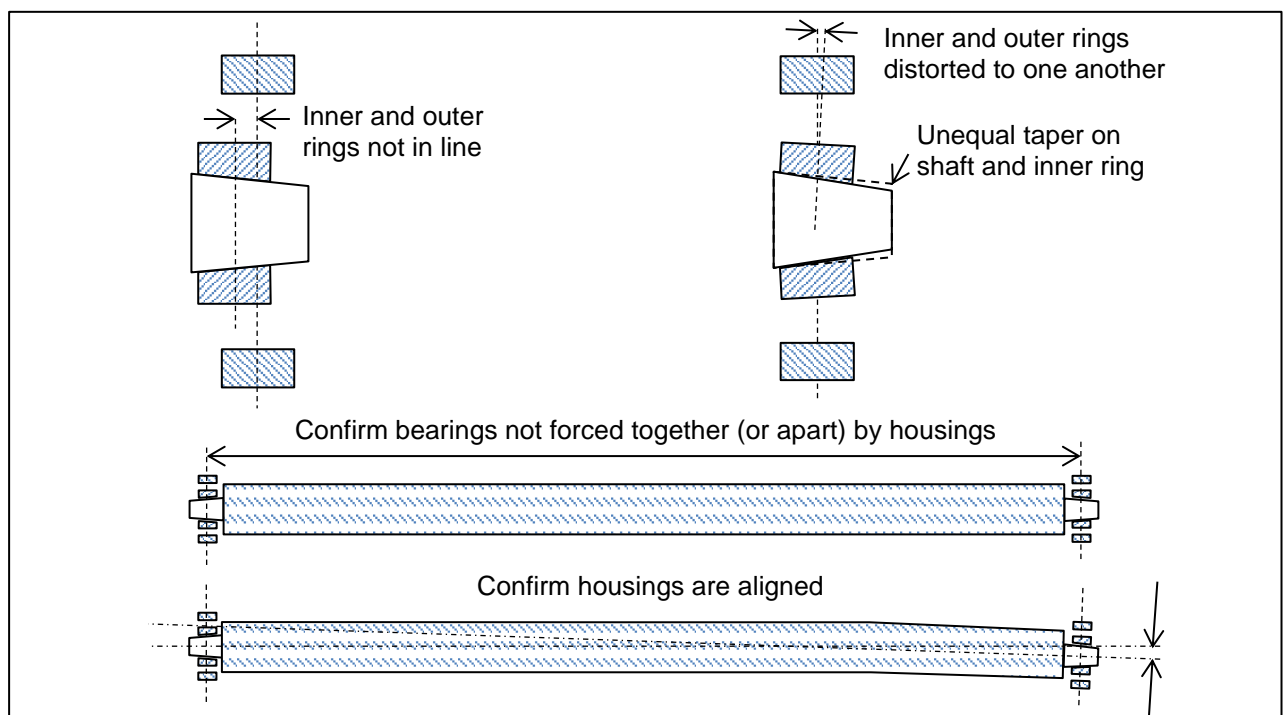
Figure 6 Possible Causes of Bearing Failures

We have reduced the bearing failure scenario down to two potential situations—high stress and hydrogen generating chemical reaction. Each of these is to be closely investigated before looking at other possible failure mechanisms. The question now becomes: What can occur to a roller bearing to create the two situations identified? Table 3 lists possible situational causes and how they can be tested. Figure 6 shows the type of problems that need to be checked.
