Physics of Failure Analysis for Roller Bearing Failures

Physics of Failure Analysis for Roller Bearing Failures: A tutorial explaining the Physics of Failure method applied to regularly failing roller bearings in a dewatering press. After three years of exhaustive efforts to solve the cause of the bearing failures it was decided to test Physics of Failure Analysis with the aim of finding a lasting answer.

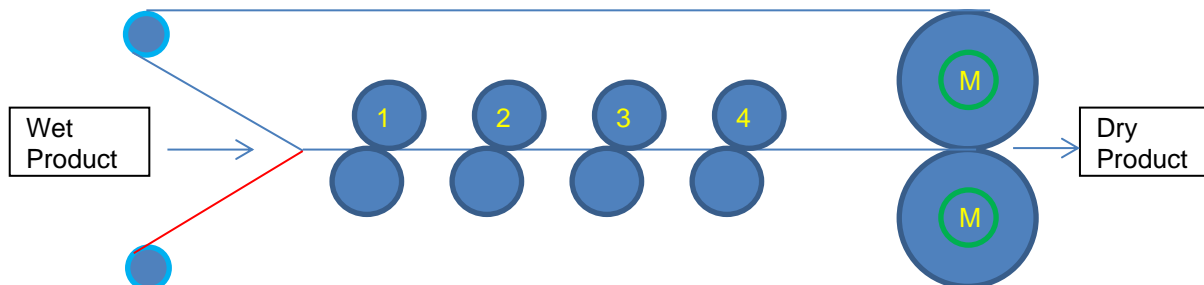
Figure 2 Roller Arrangement

Figure 2 shows how the roll sets were driven by the wire, with no direct motor drive. Operating temperature ranged 50-70C. The pressing rolls were in a chamber with a vapour extraction system at the top.

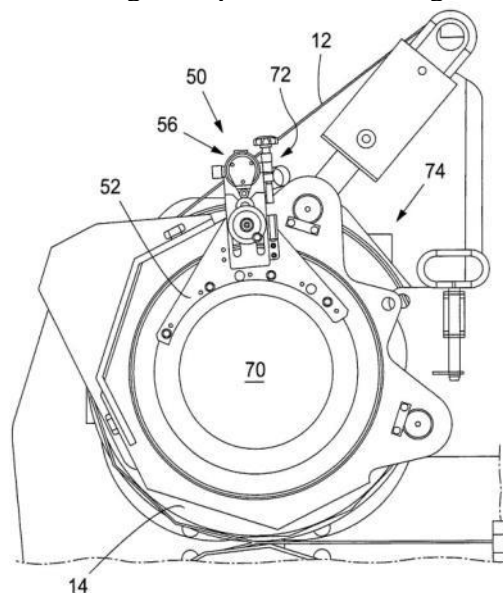
Figure 3 De-watering Press Adjustable Roller Bearing Housing

The upper bearing housing was mounted to the press using two lugs, a left and a right, each with a hole for a retaining pin. The upper housing was unmovable and solidly fixed to a 5 cm thick machine frame by 4 cm pins that went through the lugs and frame and were secured by a collar at the ends. The lower bearing housing also had two lugs for hinged pins. One hinge was fixed to the frame as described above; the other had a hydraulic cylinder mounted to permit adjustment of roller pressure (not too unlike the lugs and pins shown in Figure 3).
